Folsom Dam Safety of Dams Project Mormon Island Auxiliary Dam (MIAD) Proposed Modifications

Mormon Island Auxiliary Dam

Corrective Action Study Risk Issues

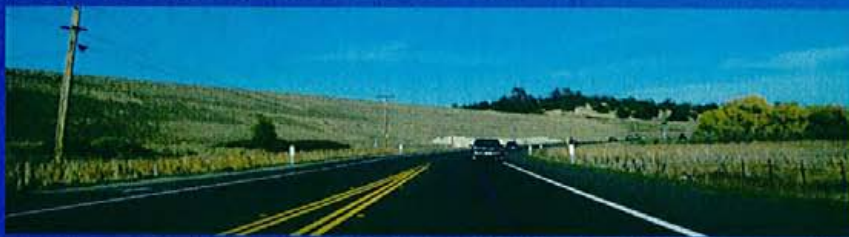
Recreation, Safety, and Circulation: Green Valley Road

- Within the MIAD project area, Green Valley Road is a two-lane undivided highway with a 45-mph speed limit.
- Presently, Green Valley Road provides an "F" Level of Service (LOS F), representing the worst level of traffic conditions.

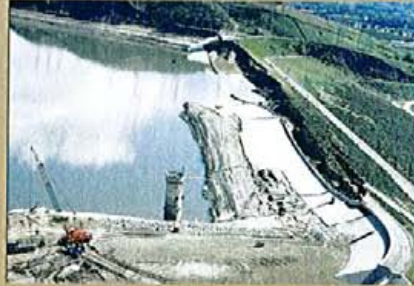
Increased water pressure can also trigger landslides and cause the collapse of dams. Lower San Fernando dam (above) suffered an underwater slide during the San Fernando earthquake, 1971. Fortunately, the dam barely avoided collapse, thereby preventing a potential disaster of flooding of the heavily populated areas below the dam.

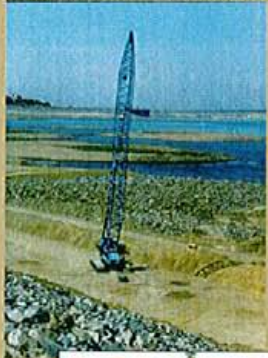
Phase 1 (1990-91): Dynamic Compaction
Upstream Constructed a 55-foot High Berm

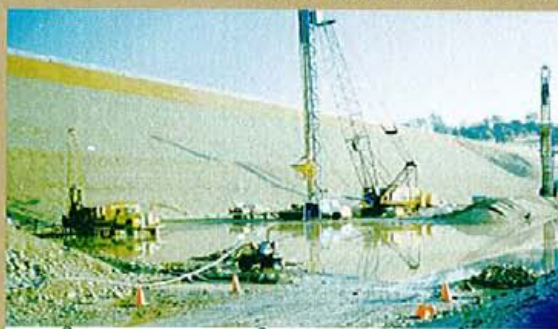
Phase 2 (1993-94):
Stone Columns Downstream

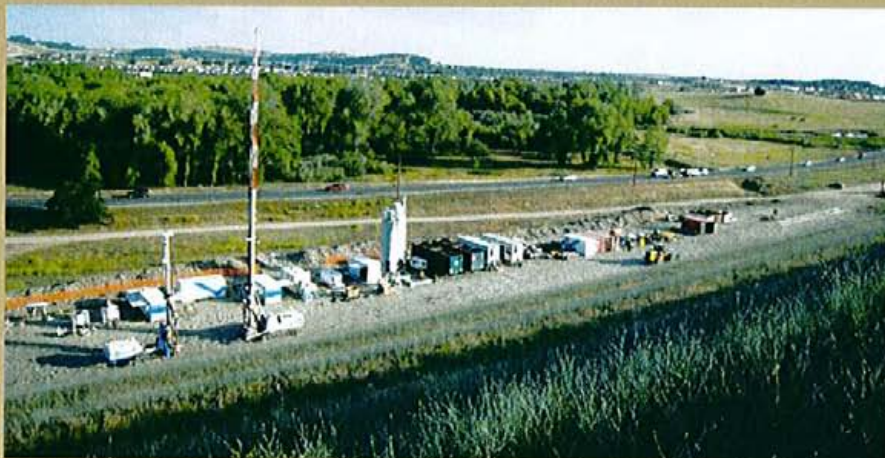
Jet Grouting Test Section

(Determined to be technically & economically not feasible)

- In-situ densification of upstream and downstream treatment zones – Jet Grouting
- Downstream overlay, Excavate and Replace with Soil or RCC
- Series of Concrete Walls in Foundation Perpendicular to Crest
- Continuously Dewater
